Maps and Imagery

Two Aerial Photos of the northwest subbasin of Smith Creek in the Campbell Creek Planning Watershed, Mendocino County CA

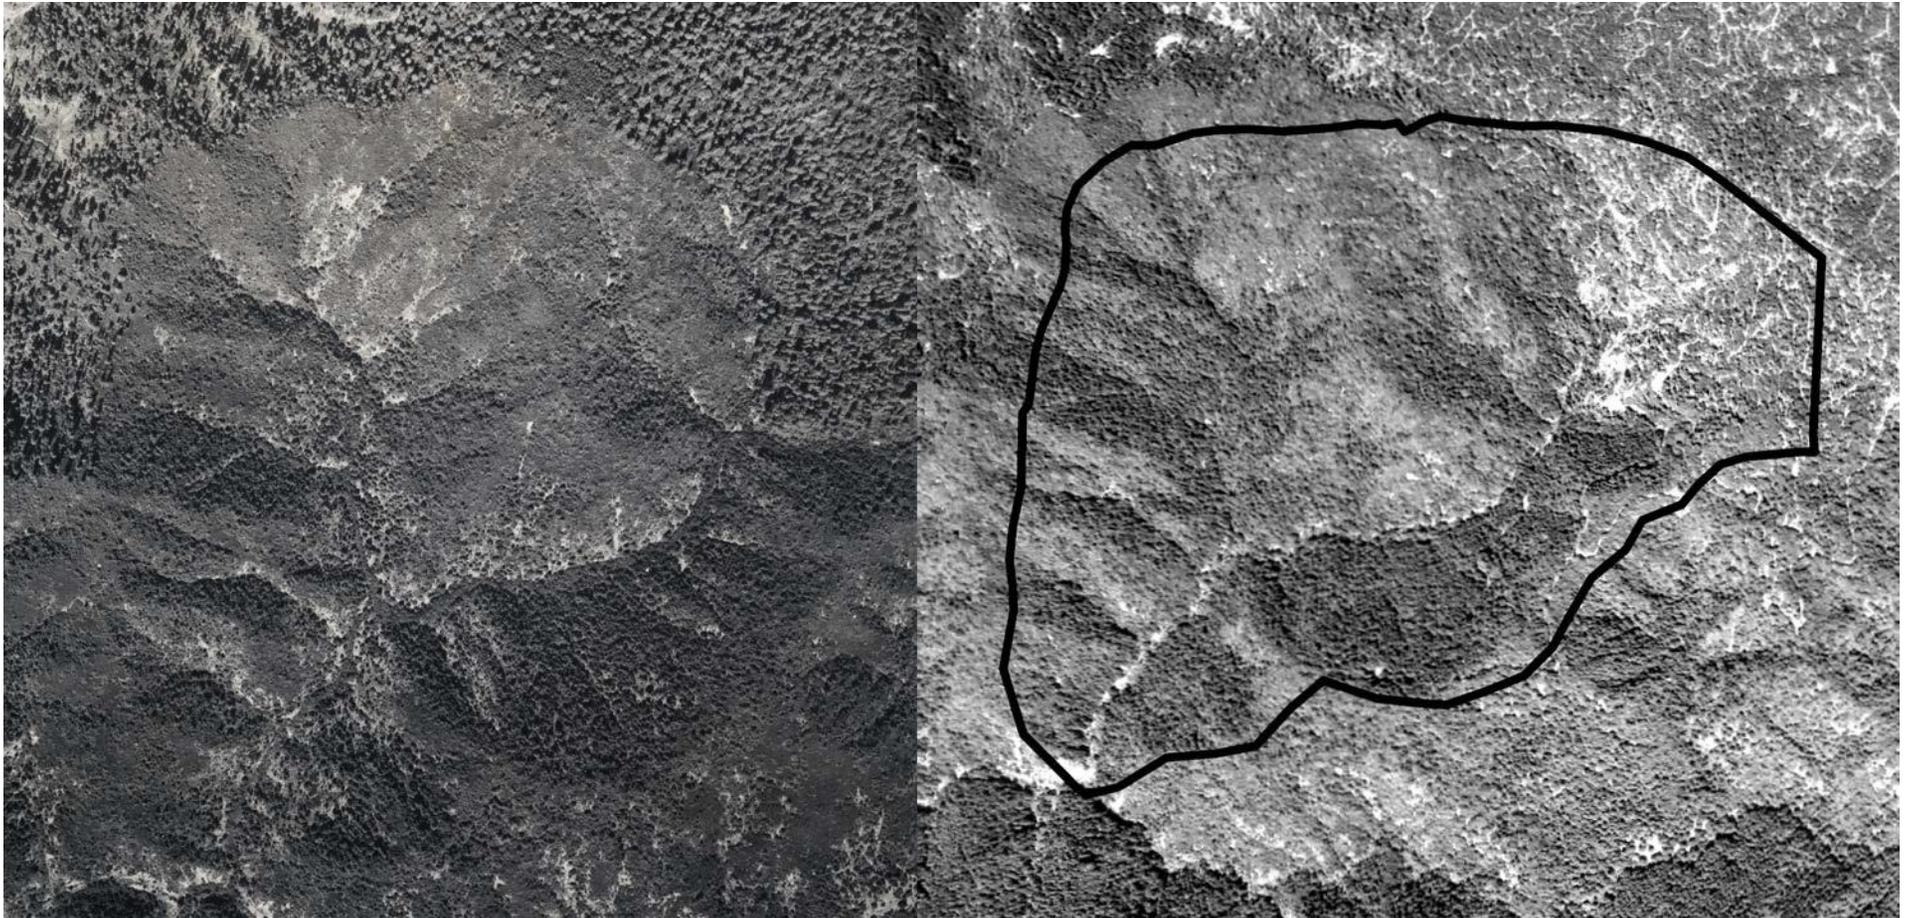
Aerial images from 1947 (left) and 1984 (right) show extensive soil disturbance. Both photos were taken after timber harvest areas were exposed to significant rainfall. The 1947 image shows that the basin was largely recovering from an extensive harvest and/or fire sometime earlier. Climate data from Fort Bragg indicate that 1941 and 1983 had record precipitation.

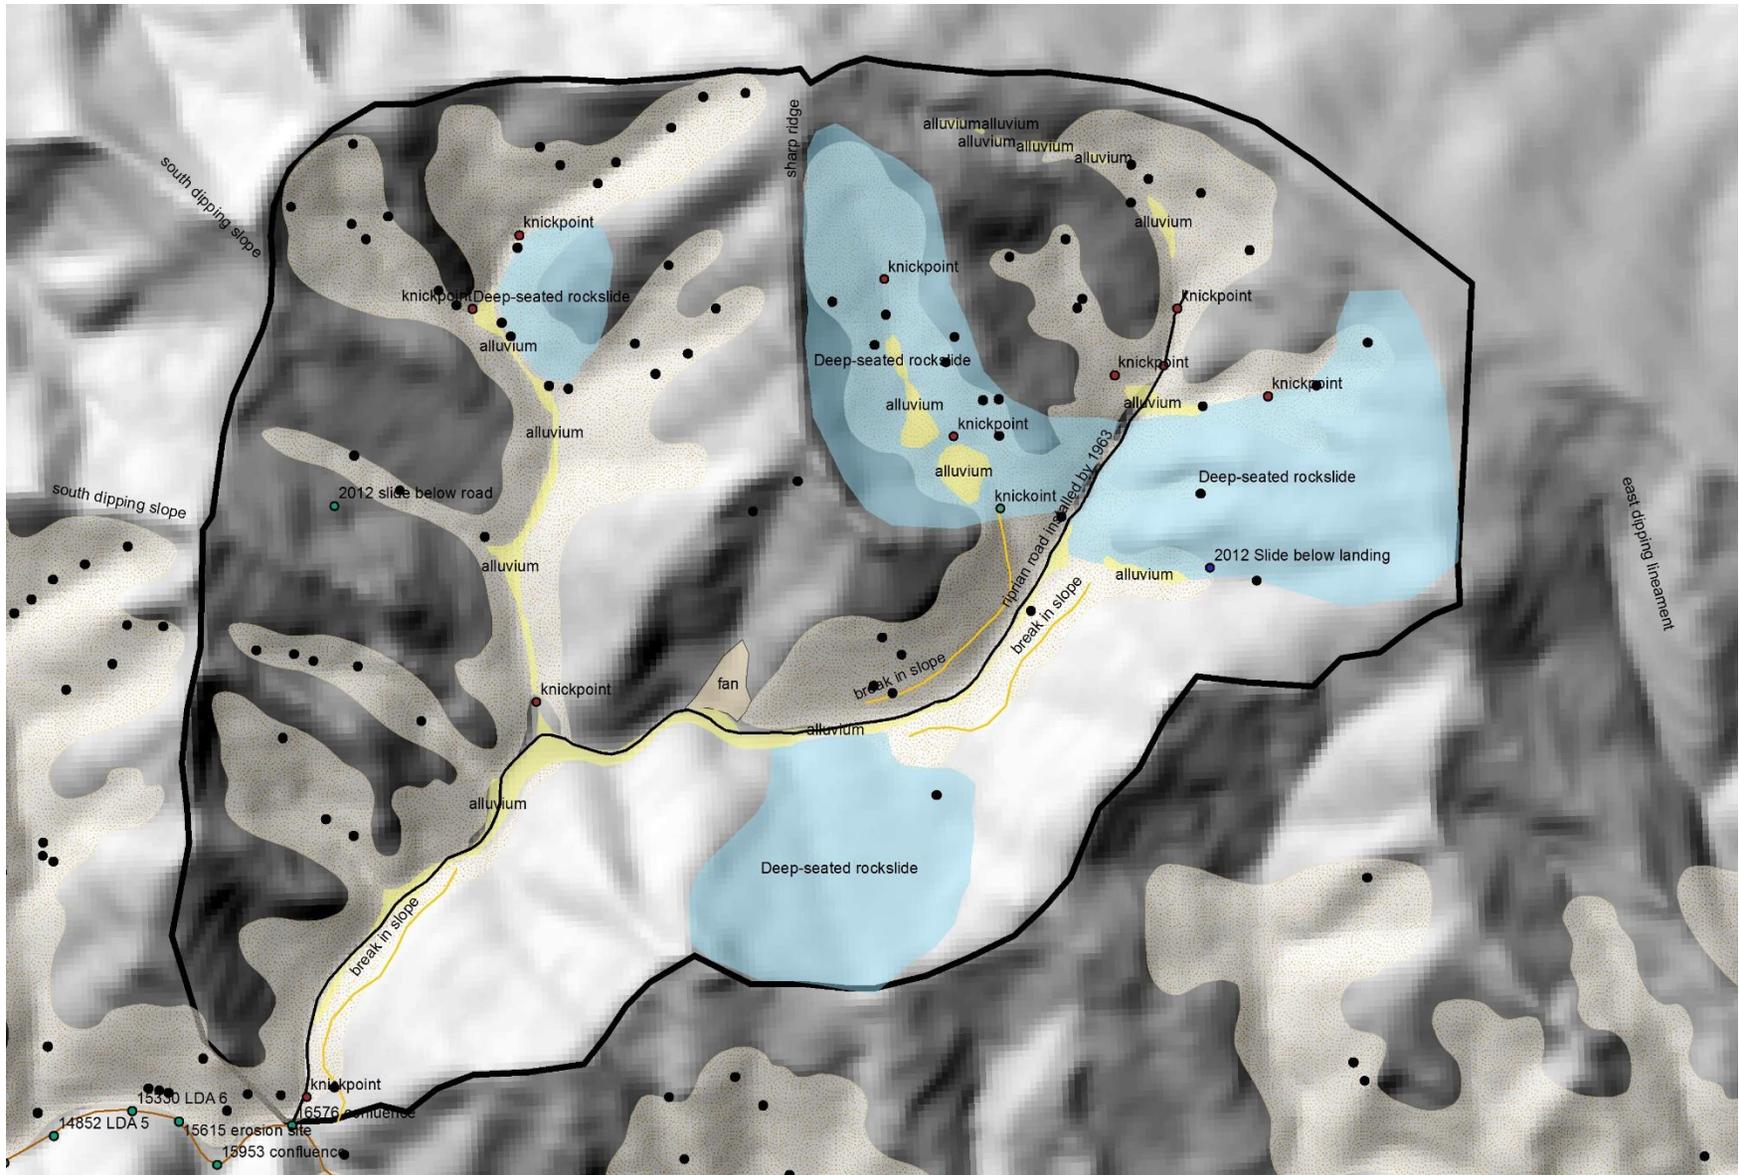
Geomorphic Units of the northwest subbasin of Smith Creek in the Campbell Creek Planning Watershed, Mendocino County CA

This map compiles data from the CGS, Lyme Timber Company, and CalFIRE. Blue polygons indicate deep-seated landslides. Overlap of blue polygons show where different mappers mapped the extent differently. Black dots represent shallow seated landslides mapped by Tim Best. Other dots are labelled. Light brown polygons represent debris slide slopes as mapped by Tim Best. Orange lines indicate the edge of gorges.
